York Railway Company

MESSAGE: BRIDGES AS FOLLOWS:

STEEL BRIDGE INSPECTION REPORT

YORKRAIL
MAIN LINE

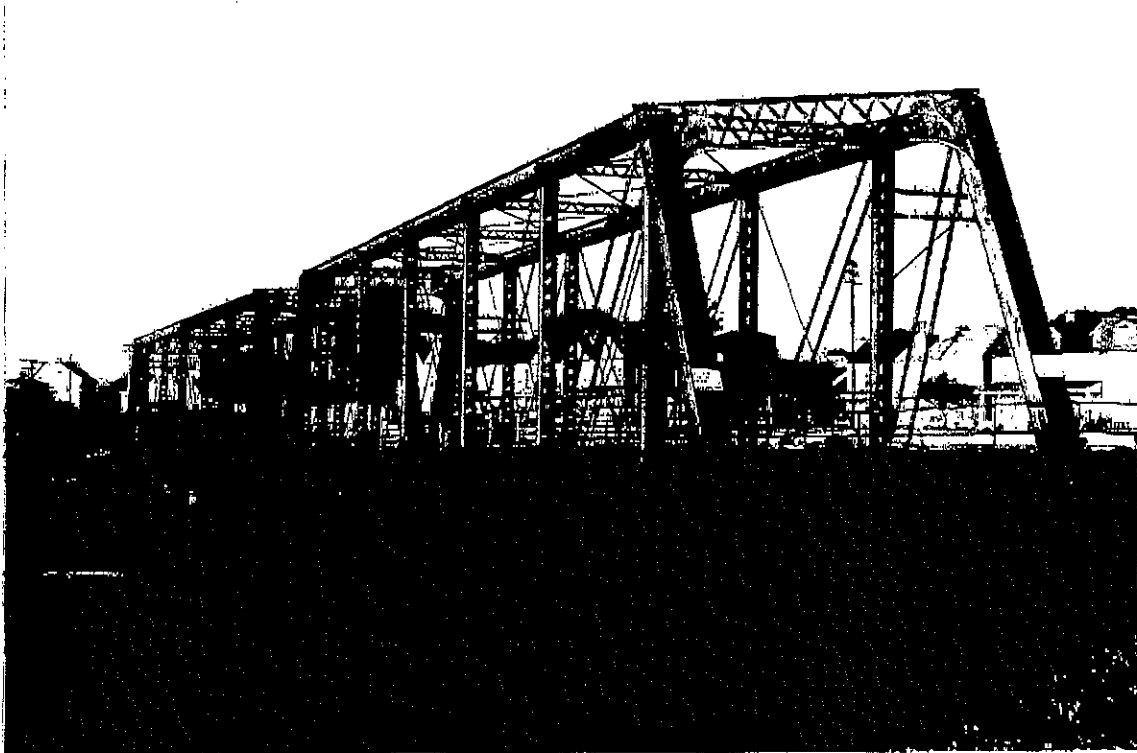
BRIDGE 15.60

Looking west.
