Form Of Intent

DEMOLITION/BLIGHT ELIMINATION PROJECT REVIEW AND CHECKLIST

Property Address: EMERGENCY 312 SOUTH GEORGE ST. YORK PA

Re: 312 South George Street, York, PA
Engineer's Report No. 0407.8.00.00

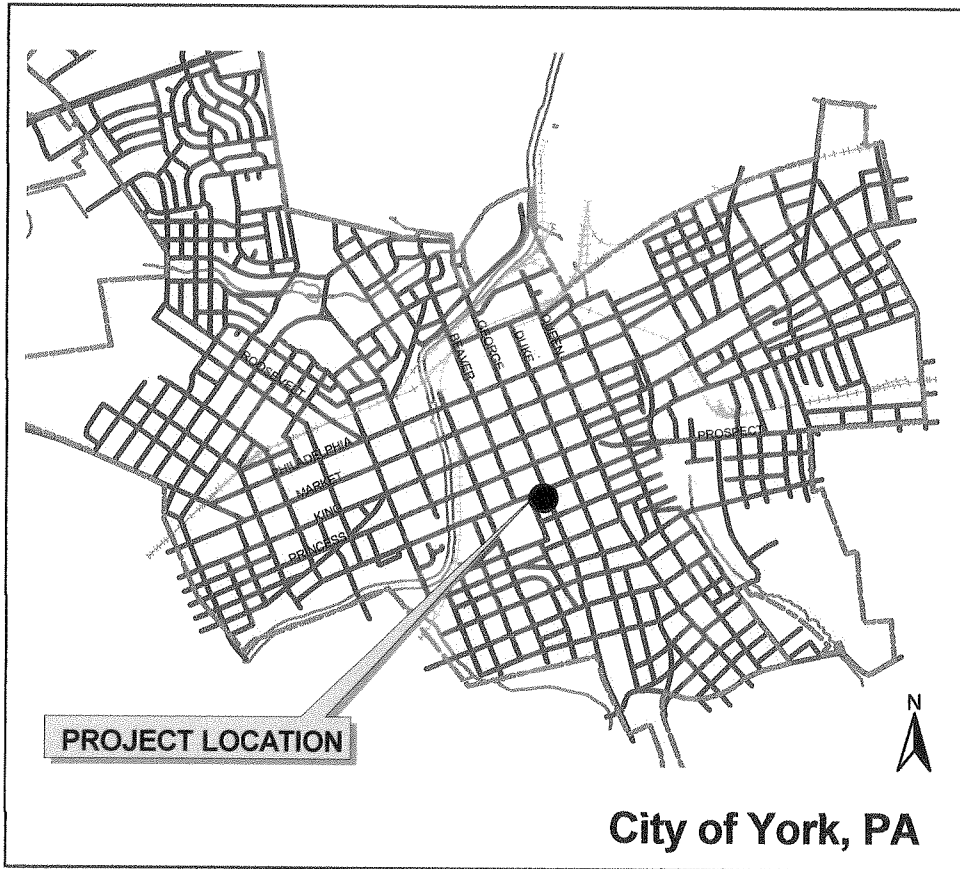
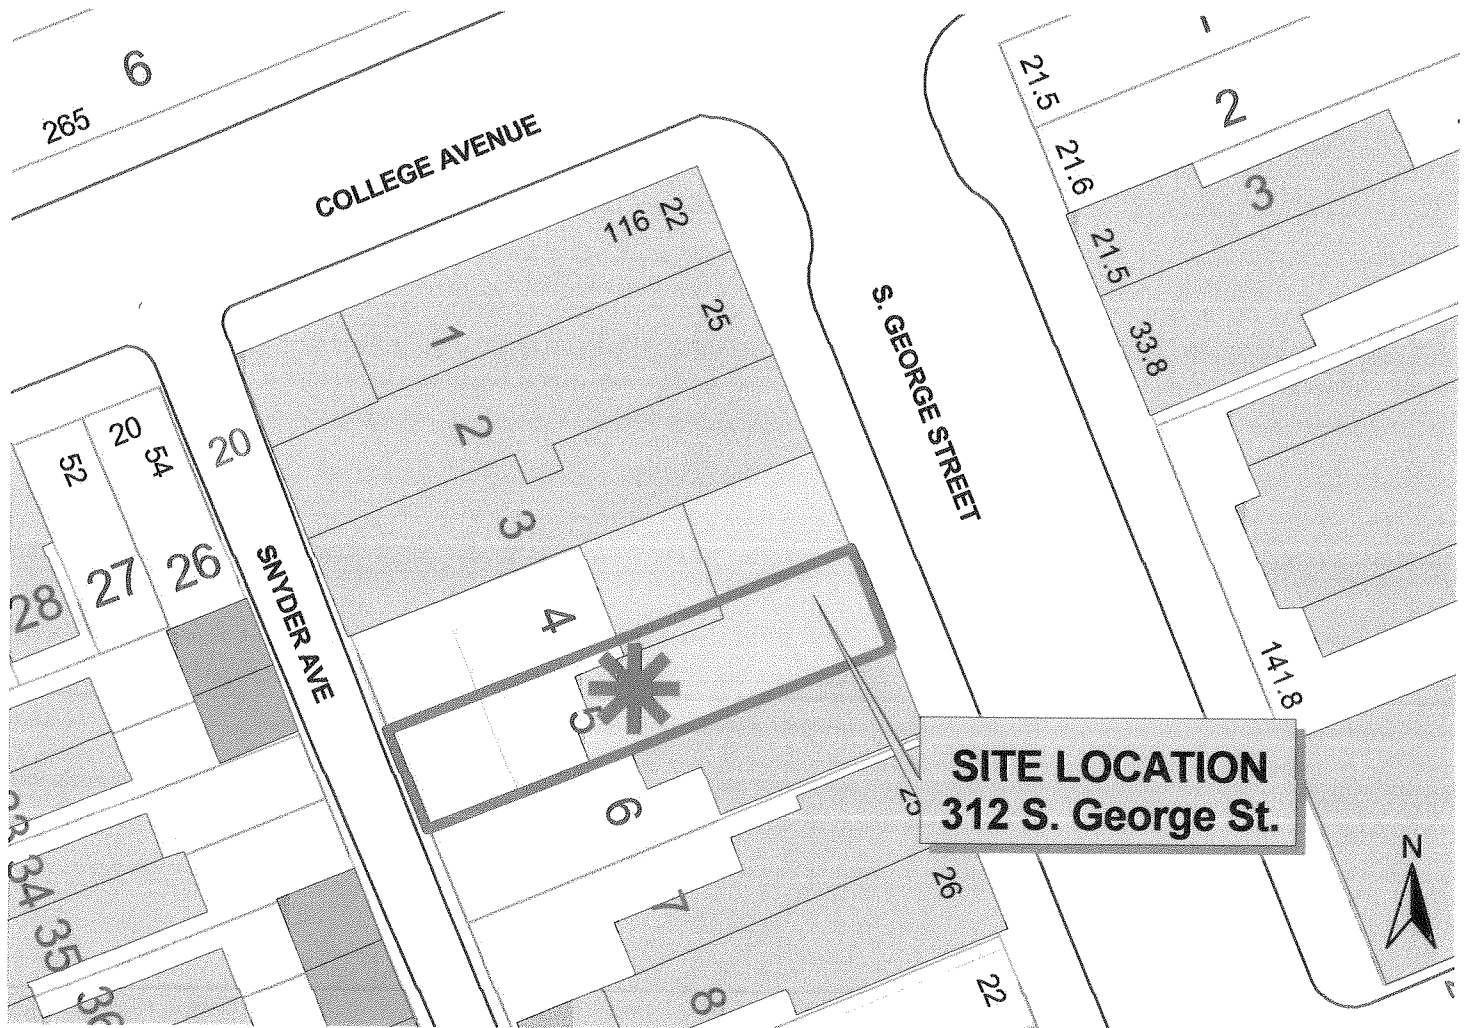
**312
S GEORGE ST
York, Pennsylvania**

The property was visually assessed from the exterior. At no time did we enter the property as we have deemed it unsafe to enter. The center of the front wall between the windows (at approximately the second floor line) was bowed in two directions. The upper portion of the wall was bowed inward and the lower portion of the wall was bowed outward. The separation between the two faces is several inches. Fresh cracks were observed at the head of the second floor window as well as below the third floor windows. The north and south walls are severely bowed inward. Only the upper portion of the south third floor wall was visible but it was noted to be severely bowed. The full extent of the north wall was visible and it was noted to be severely bowed throughout its height. The existing roof structure was observed through the exterior windows. It was noted to be completely collapsed in several locations that were visible. Rear portions of the structure were also noted to be in various stages of collapse. Large piles of brick were noted on the ground below a section of the north wall.

Based on the extensive damage and failures noted throughout, the exterior walls have become unstable. The remaining framing, both wall and floor, is in various stages of rot and/or failure (i.e. active state of collapse). As a result, this has left the exterior walls in an unbraced condition. A tall, slender masonry wall that is otherwise unbraced, is very unstable. The damage that was observed today in the front wall is severe and actively continuing to move.

Given the extent of damage noted throughout the property, coupled with the fact that the majority of the structure was largely inaccessible (for safety reasons) because of the extent of framing failures, we would recommend that the property be demolished. The other major concern is the stability of the exterior walls. Should the walls reach a point where the unbraced length exceeds acceptable limits (as a result of the failed or rotted framing), a sudden and catastrophic failure could occur. Given that the property has degraded extensively throughout since the last observation, coupled with the front wall in an active state of collapse, our recommendation is to demolish this property within 24-48 hours. In its current state, the front and or side walls could collapse without warning. The sidewalk and parking spaces in the immediate vicinity of this property should be cordoned off. If the property is not demolished in this window of time, then our recommendation is close the sidewalk, parking spaces, and the southbound lane of George Street with a more permanent fencing type guard until such time that the property can be demolished.
