Appendix G

DEP File Records

HAZARDOUS WASTE INSPECTION REPORT
Generators - Part A

HAZARDOUS SITE CONTROL DIVISION
U.S. ENVIRONMENTAL PROTECTION AGENCY

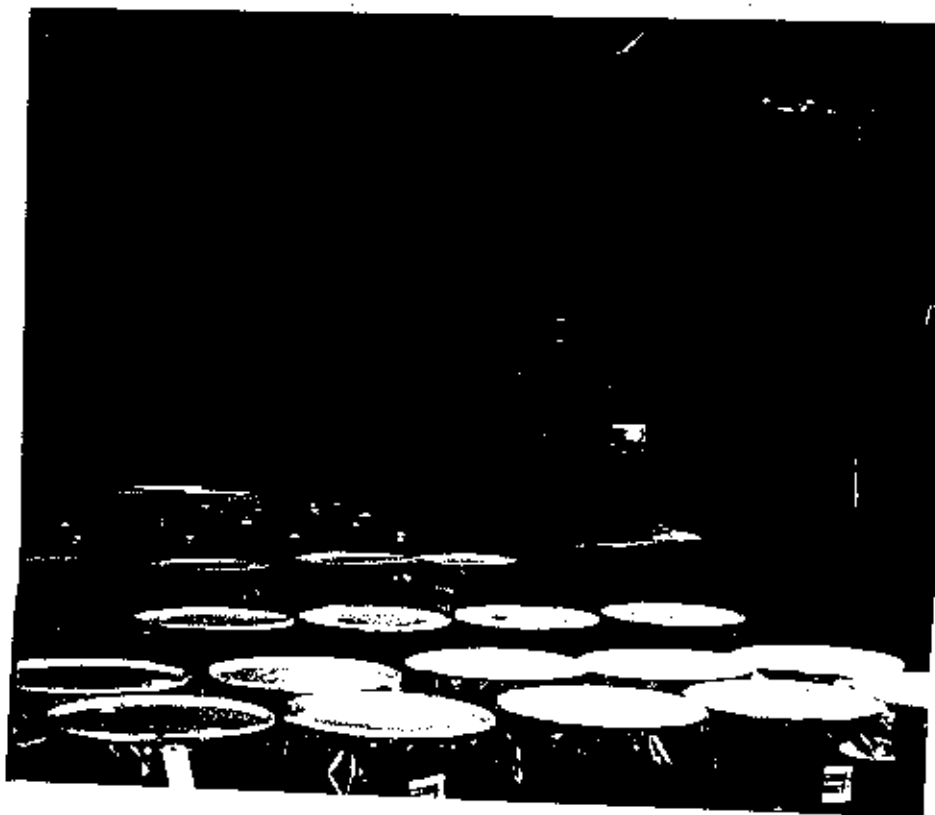
Photo 4 Filter Pressed Sludge Drum
storage area.

The former hazardous waste drum storage area was a 15- by 30-foot concrete-lined floor inside the northwestern corner of the warehouse storage area. No HNU readings above background were recorded, and no evidence of spills was observed during the site visit.^{2,3}
